ESCOT Gearbox, Fault tracing procedure  
Quy trình truy tìm lỗi hộp số Escot

UDIS Competence Development

# Fault Tracing Process/ Quy trình truy lỗi

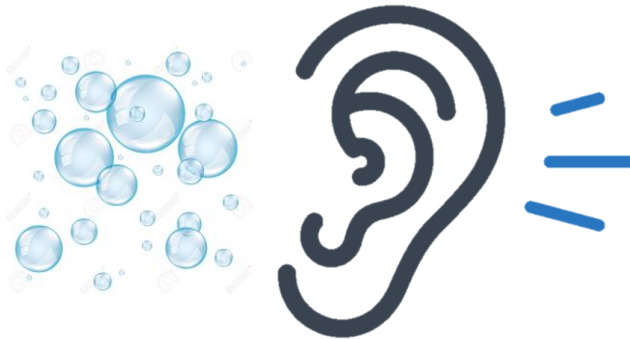
- No oil leakage from the gearbox/ Không có rò rỉ nhớt từ hộp số
- No air leakage from the pneumatic system of the gearbox/ Không có rò rỉ khí nén từ hệ thống khí nén của hộp số
- The last service and maintenance was happen in 69500 km/ Số km cho lần bảo dưỡng gần nhất là 69500 km
- No DTCs / Không có DTC

- Test drive shows that the gear shifting problem happens in manual mode as the driver said before/ Lái thử cho thấy rằng xảy ra vấn đề chuyển số ở chế độ thủ công như lái xe đã nói trước đó

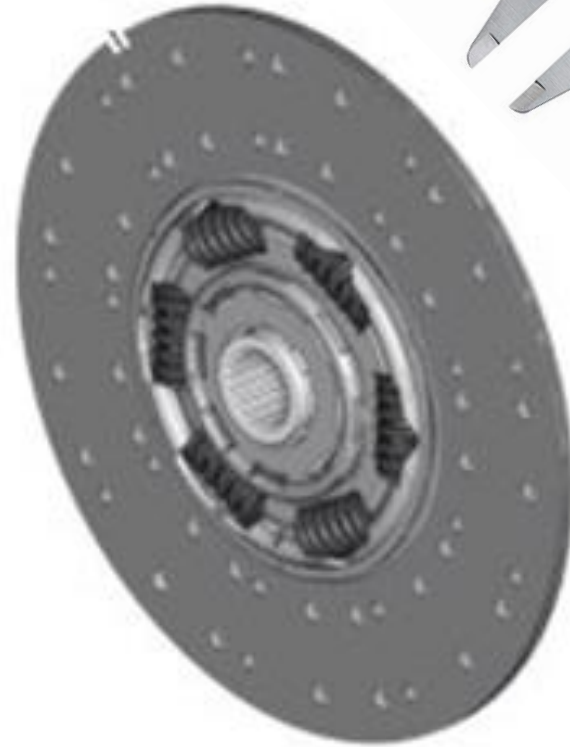
## Kiểm tra và đo trực quan đĩa ly hợp

Độ dày đĩa: **11mm**  
Mòn tối đa: **3 mm**  
**1.5 mm** mòn bên hông

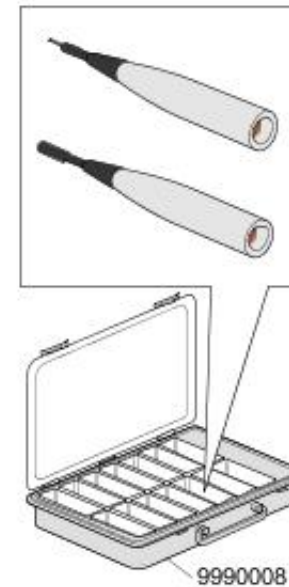
# Short circuit checks/ Kiểm tra ngắn mạch

Chân A13B.X3:b3

All other pins except **a3** at connector X3  
Ground point  
Tất cả các chân khác trừ **a3** tại kết nối  
X3 điểm nối mass

Open circuit/ Hở mạch

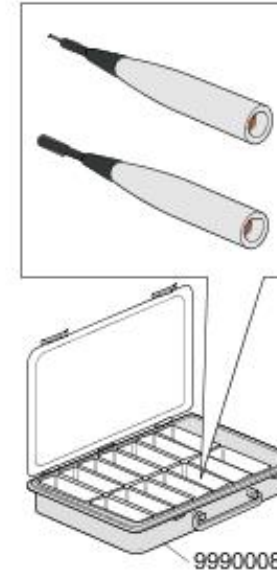
# Resistant checks/ Kiểm tra điện trở

Chân X3:b2  
Chân X3:a2

1.03 to 1.3 K $\Omega$
